AAC – Your advanced solution for Space and Beyond

Examples of Failure Analysis Images

Christian Jogl (AAC)

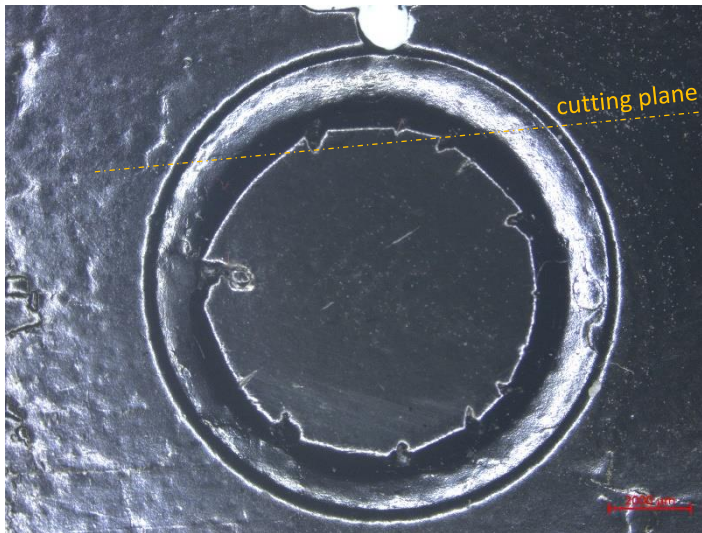
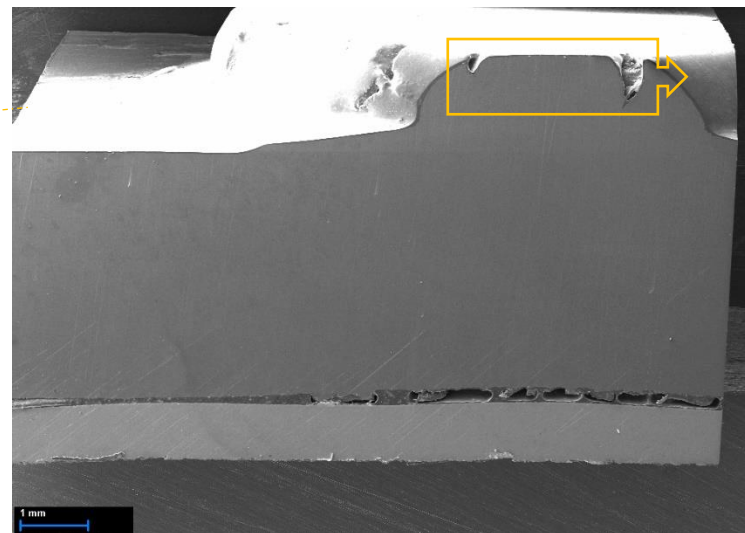
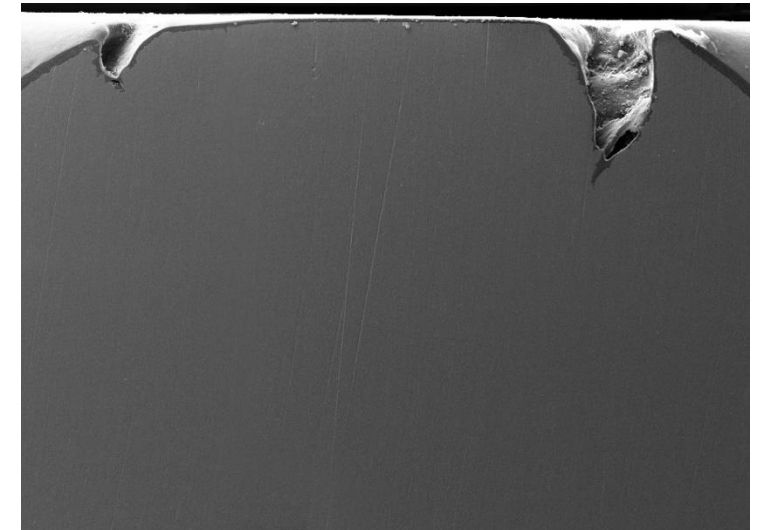
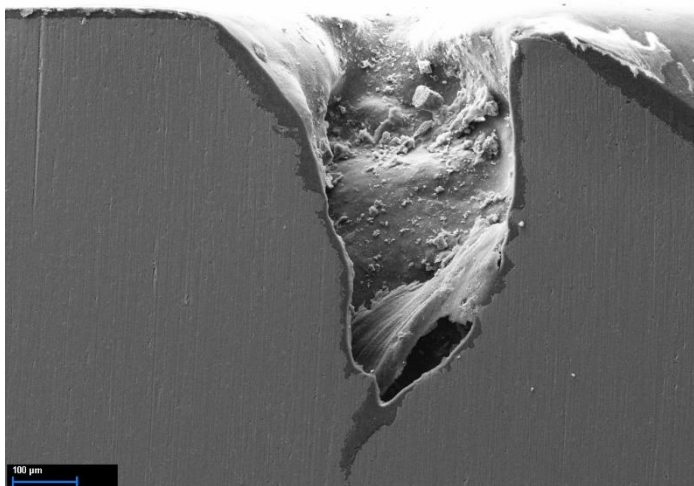
Examinations of a metal rivet

Electron-microscopic assessment of the cross-section

- 2 cracks (200μm and 600μm deep)
- Coating detectable inside the crack
 - **Crack formation BEFORE coating process**
- EDX-analysis inside the crack: found Na and Cl
 - **Corrosion issue**

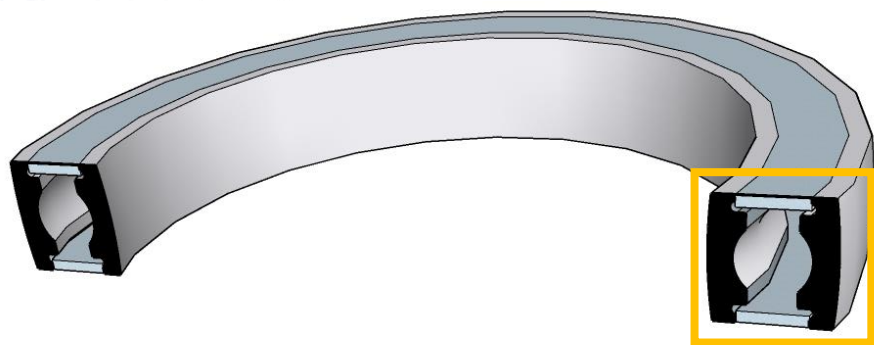
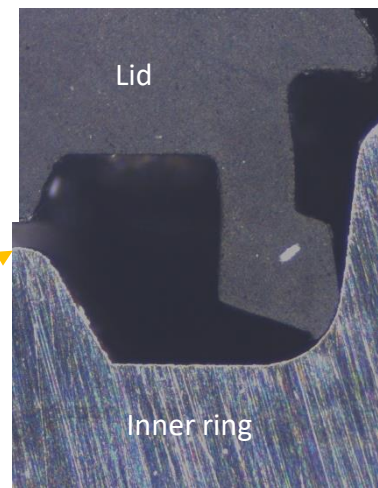
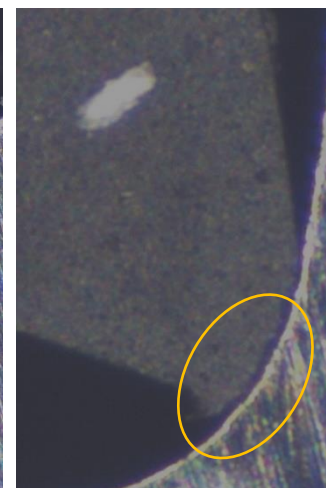
- Deformation of the bearing lid in the area of the inner edge
- Signs of an excessively tight fit
- Increased torque of the bearing

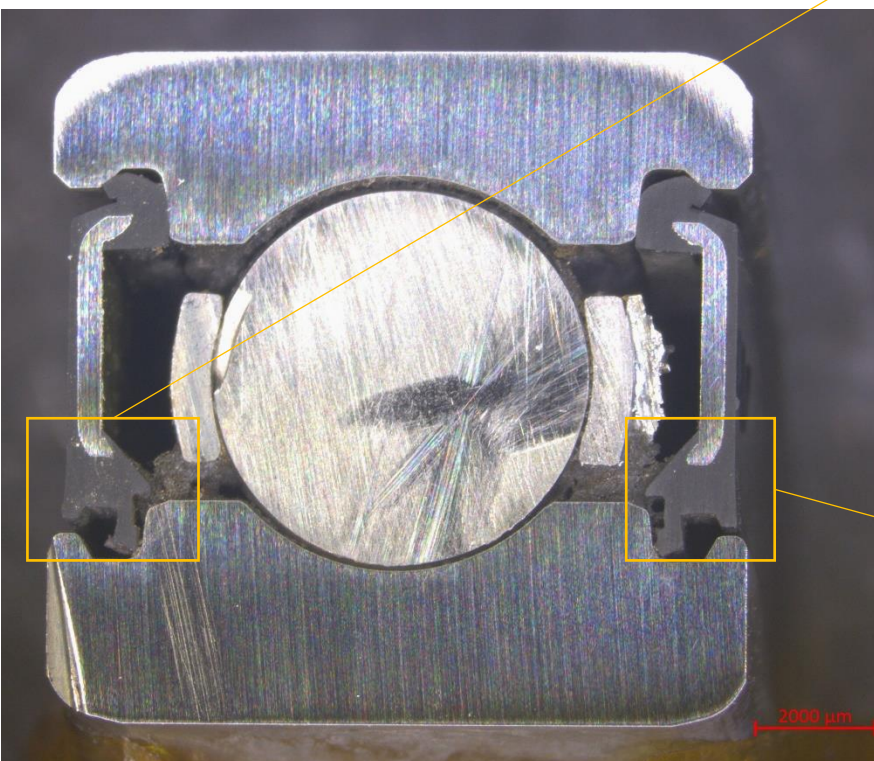
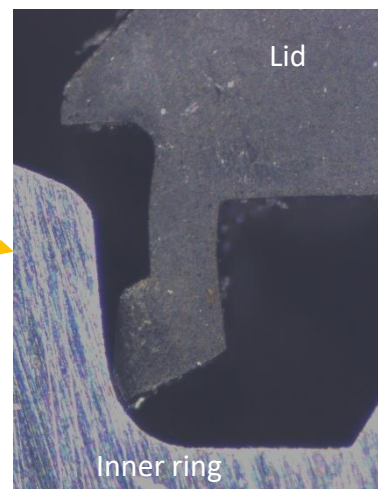
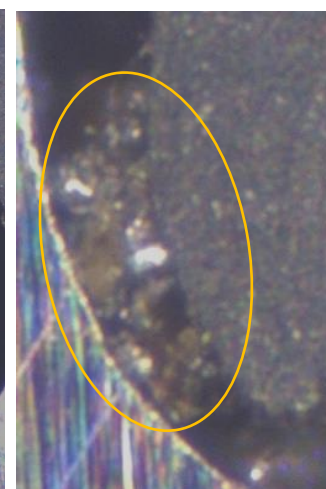
- No deformation of the bearing lid
- Gap filled with grease
- **Desired condition**

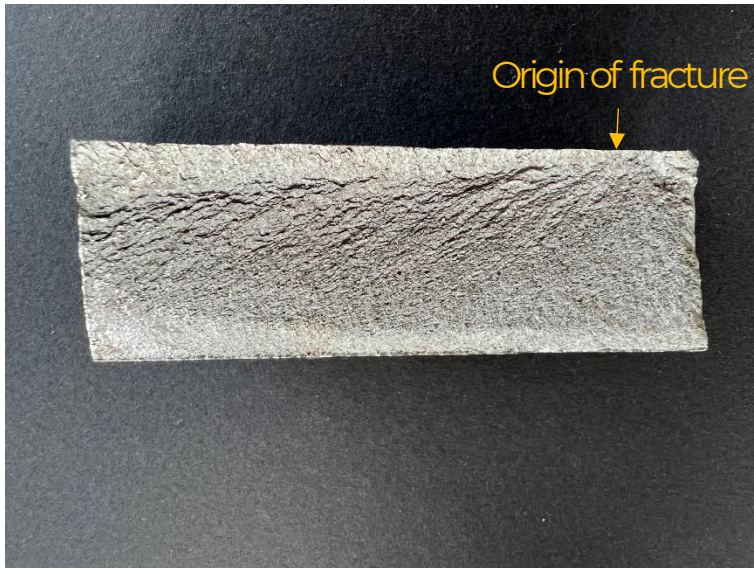
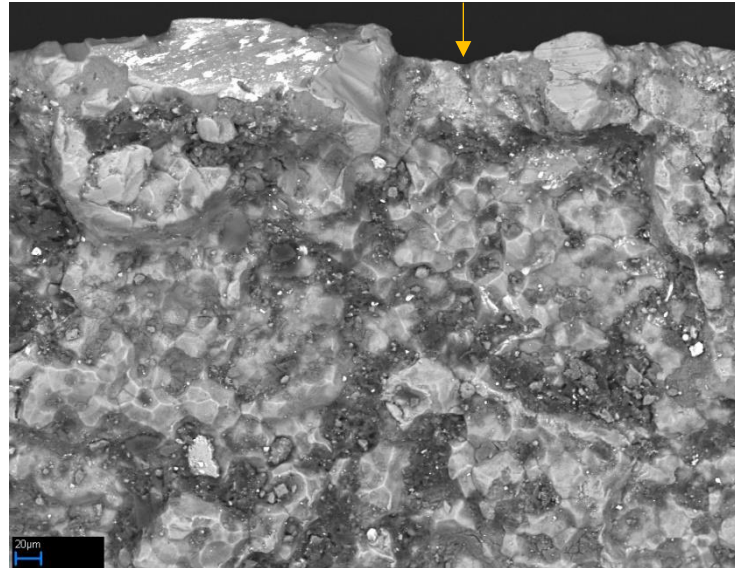
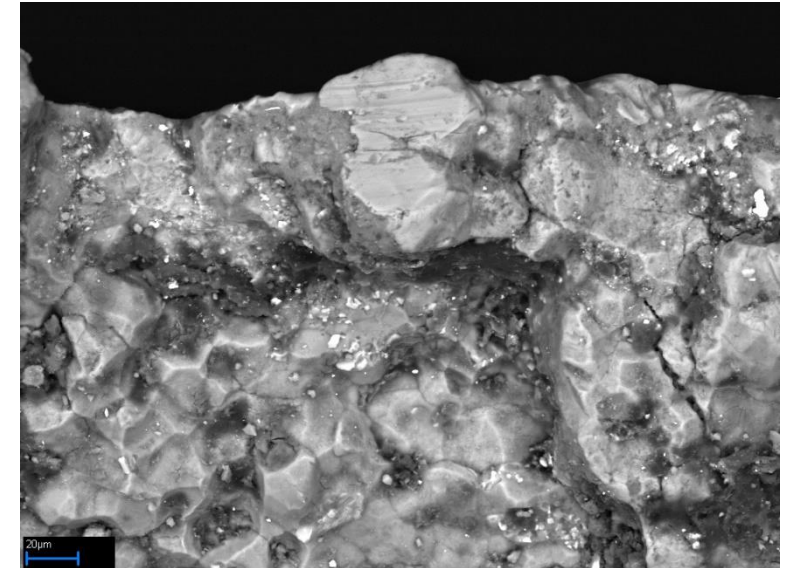
- Classification of the fracture pattern as an intergranular brittle fracture due to local mechanical overload.
 - Local plastic deformations in the area of the fracture origin: occur after/during the opening of the crack
 - Oxidic deposits on the surface
- **From the clear identification of the starting point of the fracture, the underlying cause of the damage can be derived. This provides useful inputs for the optimisation of the mechanism's design.**

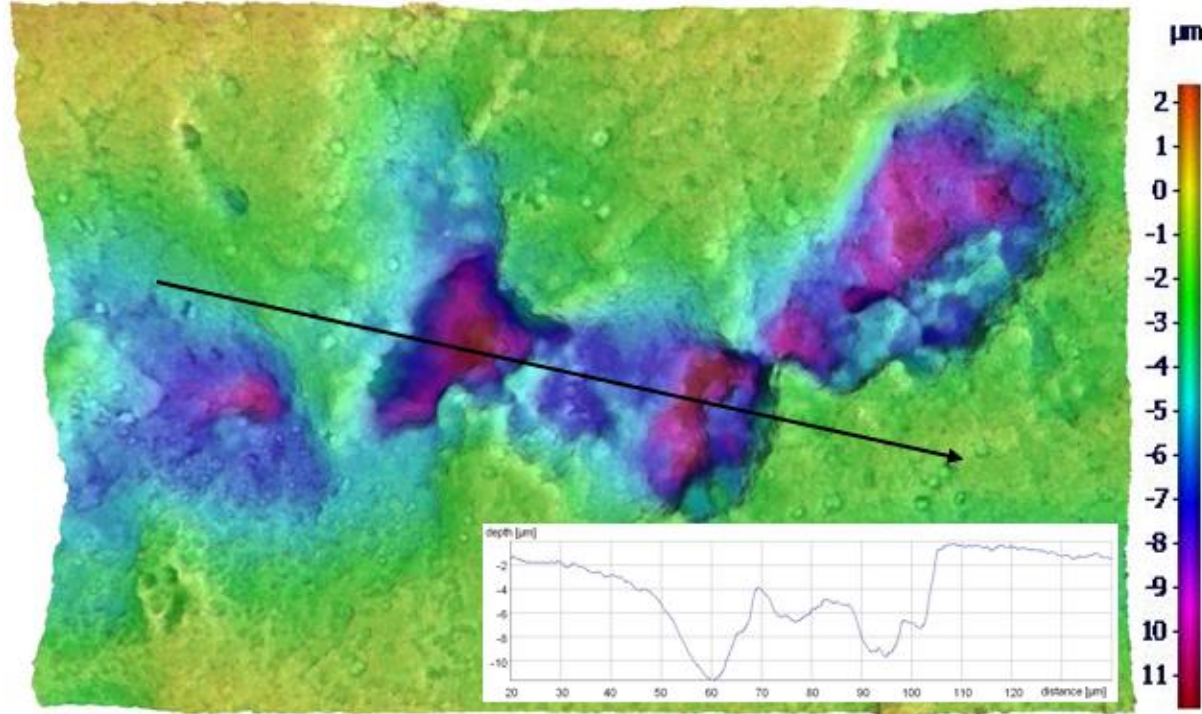
Representation of a 3D printed surface to determine the roughness parameters

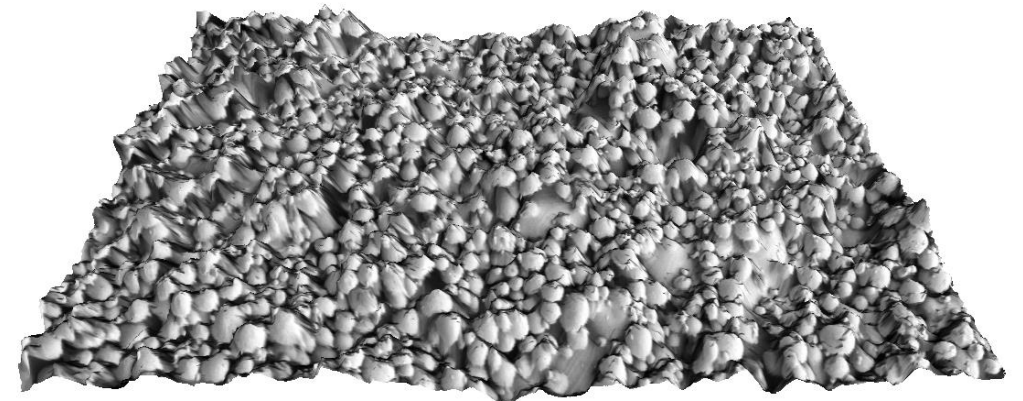
3D-representation and measurement of a damaged area

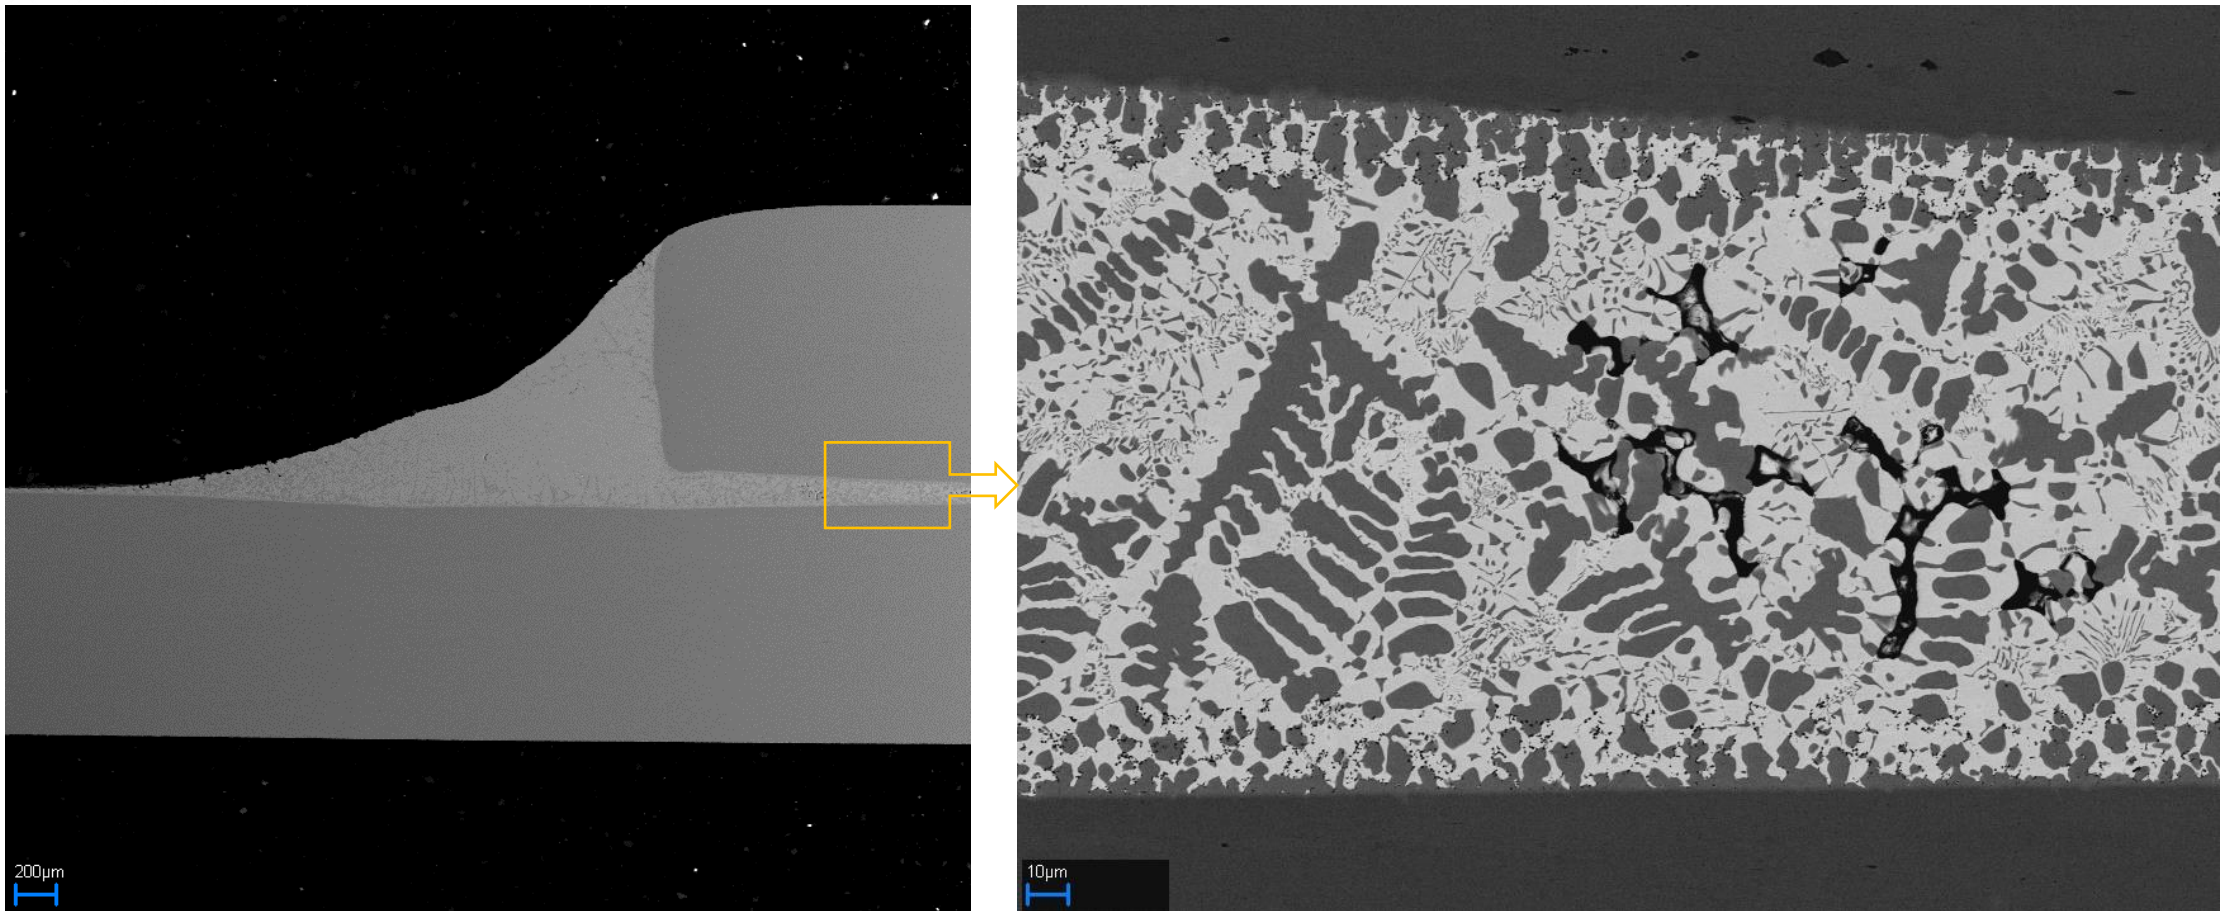
→ Investigating the microstructure of the (Cu / Ag / Zn) - soldering shows **pores and defects**

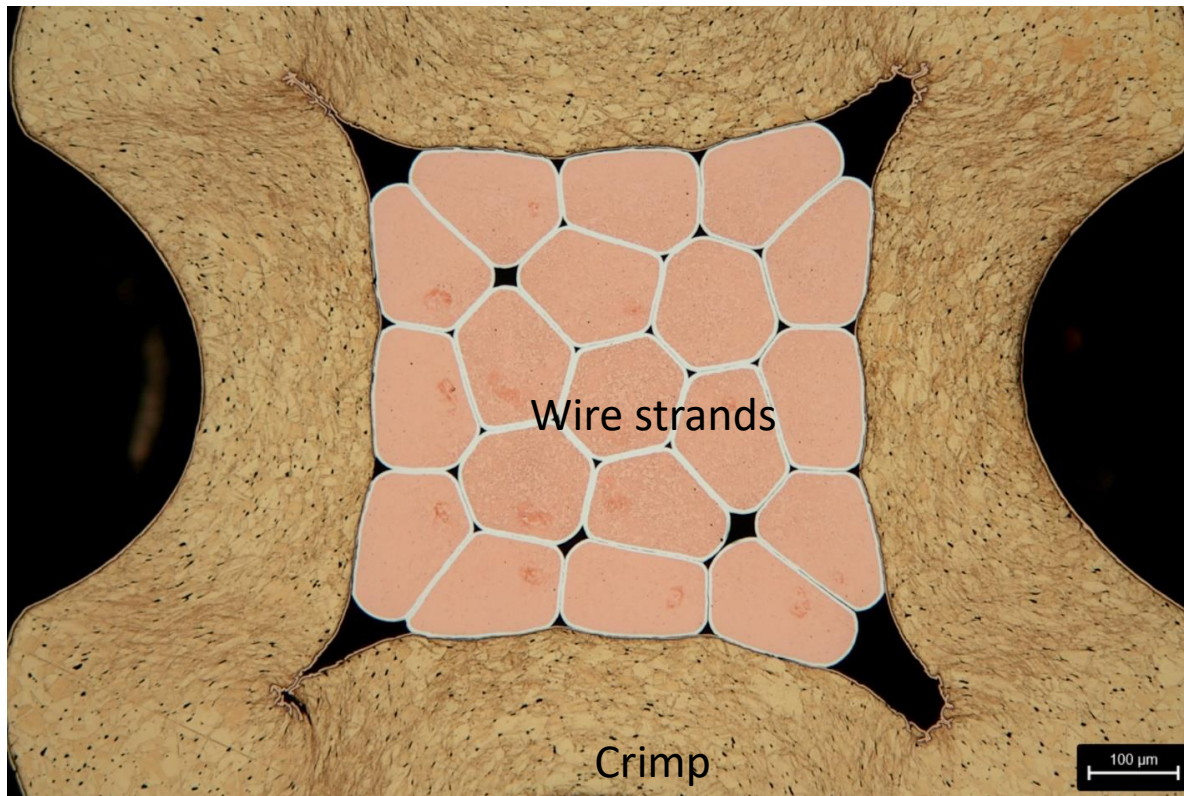
Light-microscopic Image of the cross-section through a crimped contact.

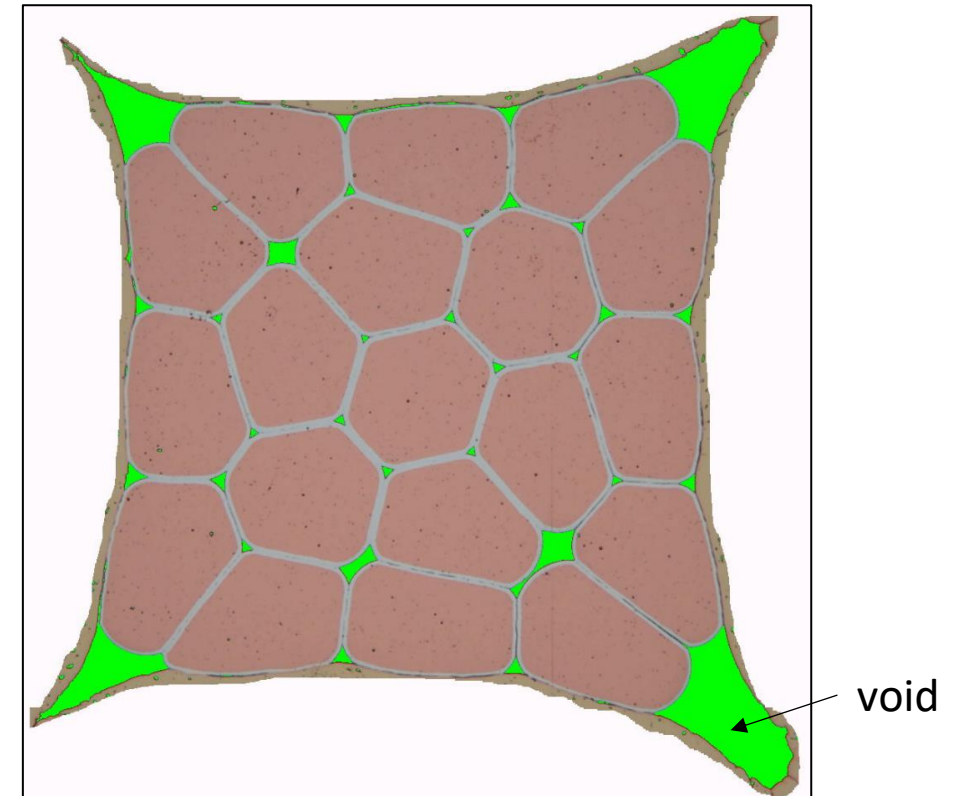
Quantitative determination of the proportion of defects using specific evaluation routines

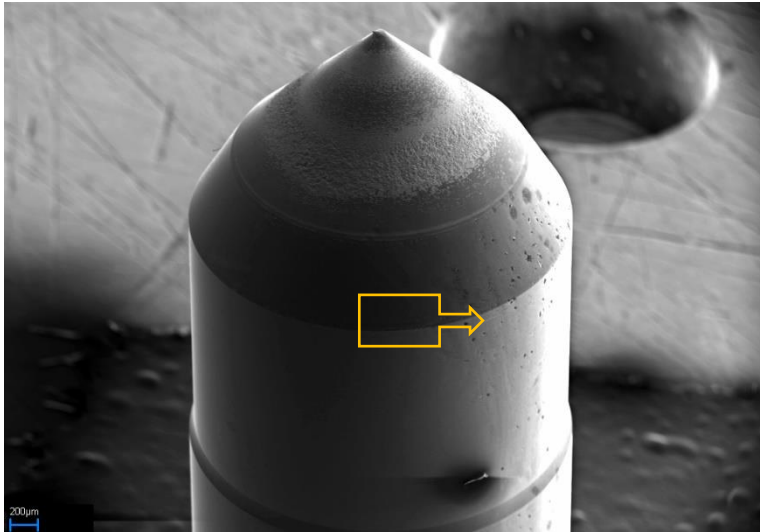
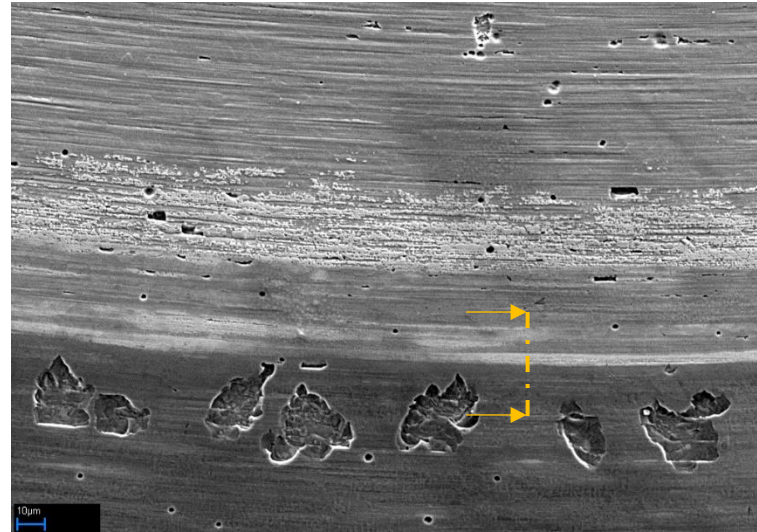
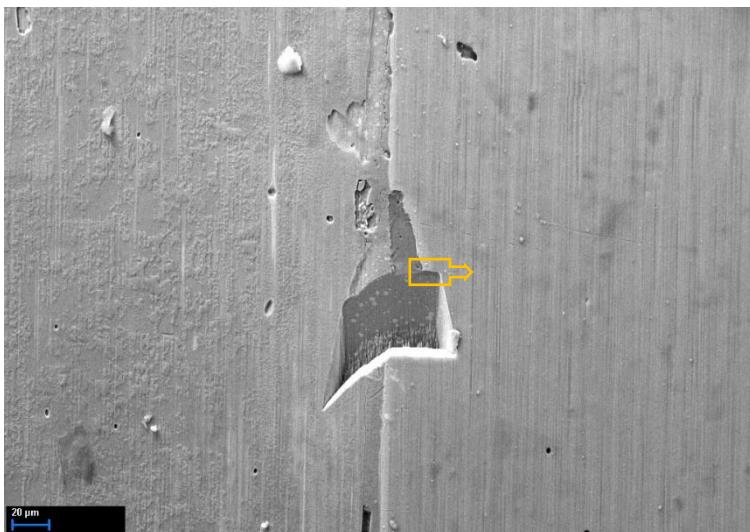
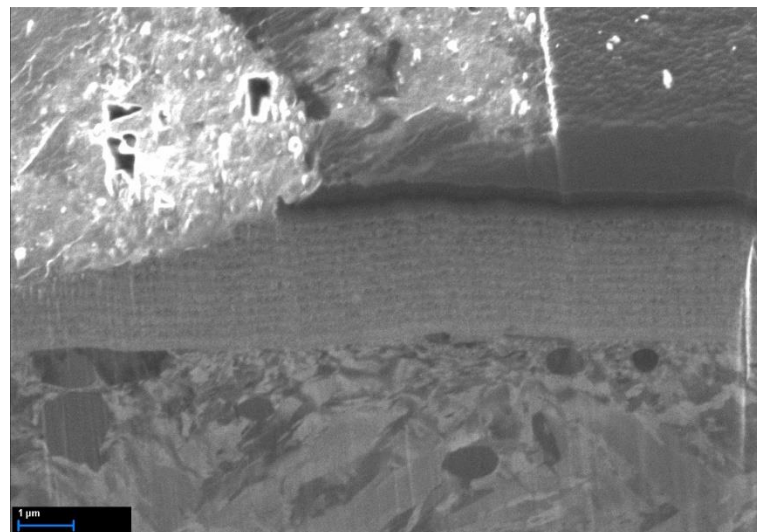
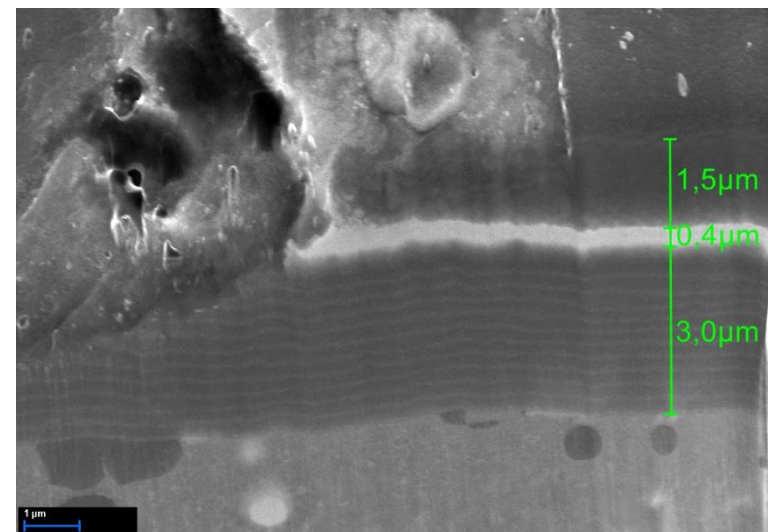
FIB-cut in the contact area:

→ **Continuous removal of the coating (no flaking)**

→ **Structure of the coating:**

~3,0 μm Multilayer- Basecoating

~0,4 μm Interlayer

~1,5 μm Functional top layer

→ **Grain structure in the base material**

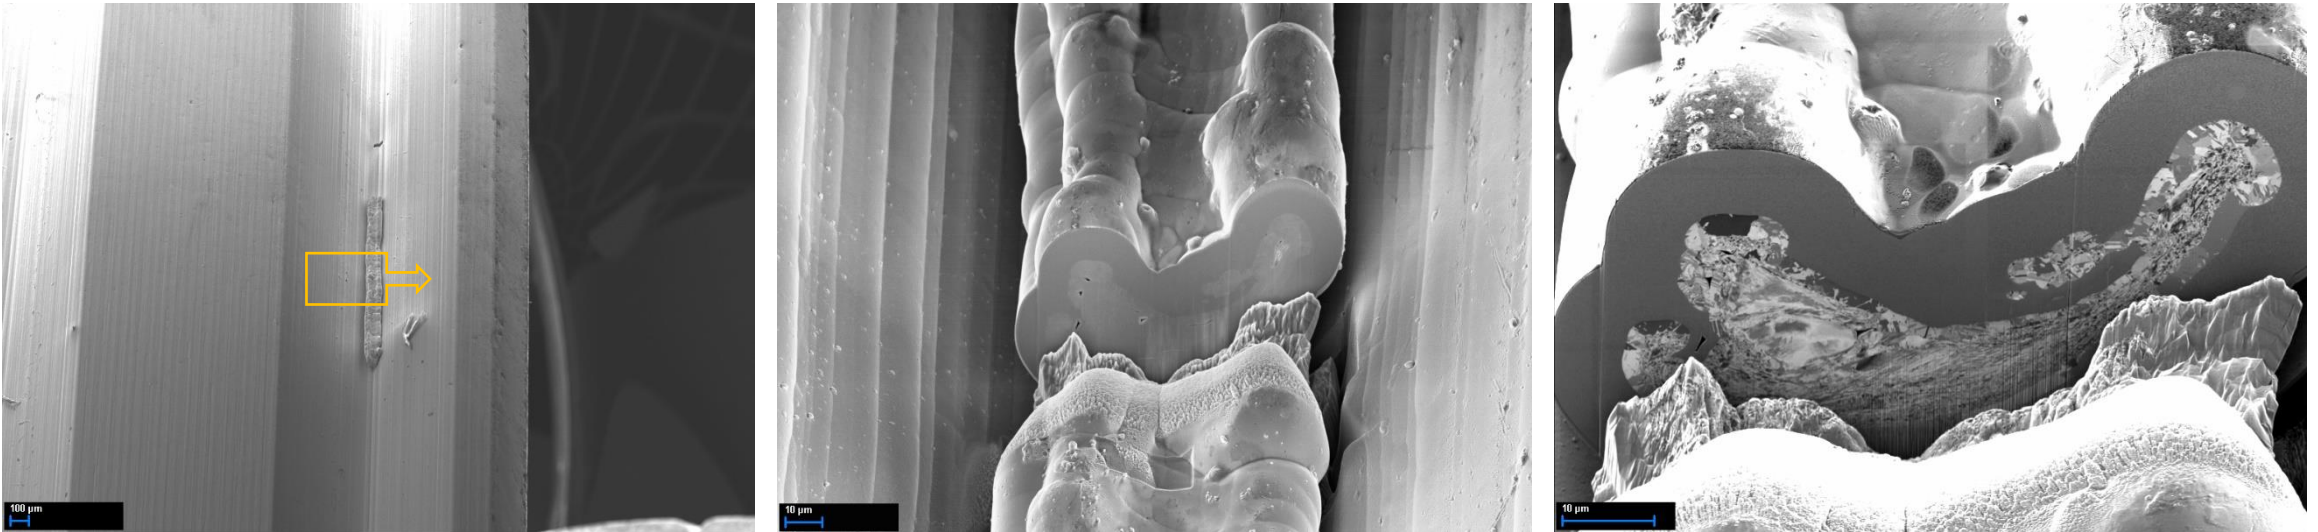
→ Analysis on a noticeable contamination in the V-groove of a slip ring:

The FIB-cut into the contamination reveals:

- Metallic grain structure inside the contamination
- The contamination is fully covered with coating

→ **No failure during coating process**

→ **Production chip originating from BEFORE the coating process**

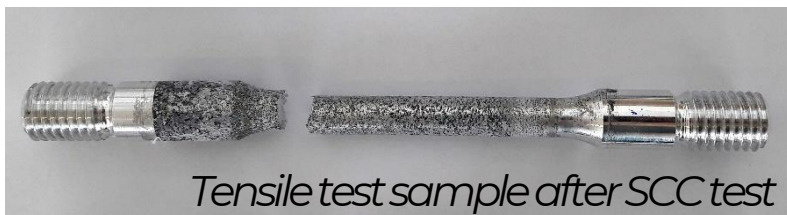
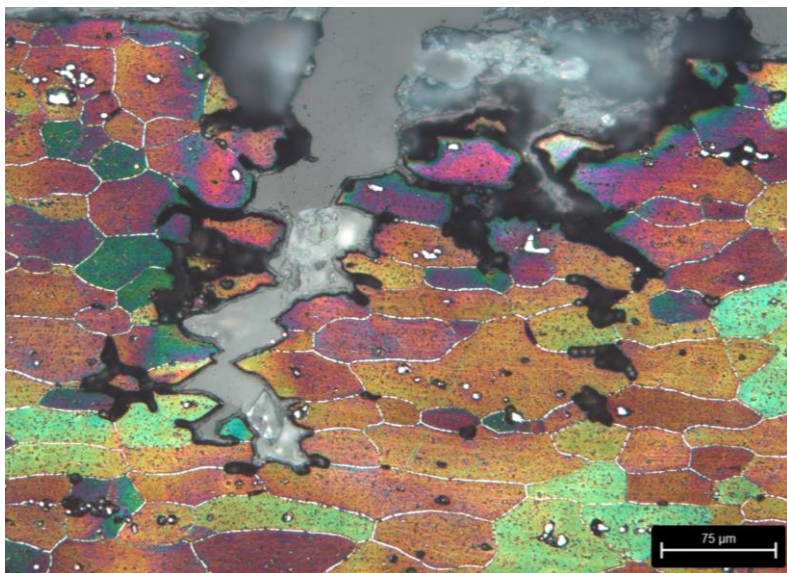
Light-microscopic image of the cross-section (acc. to ECSS standard)

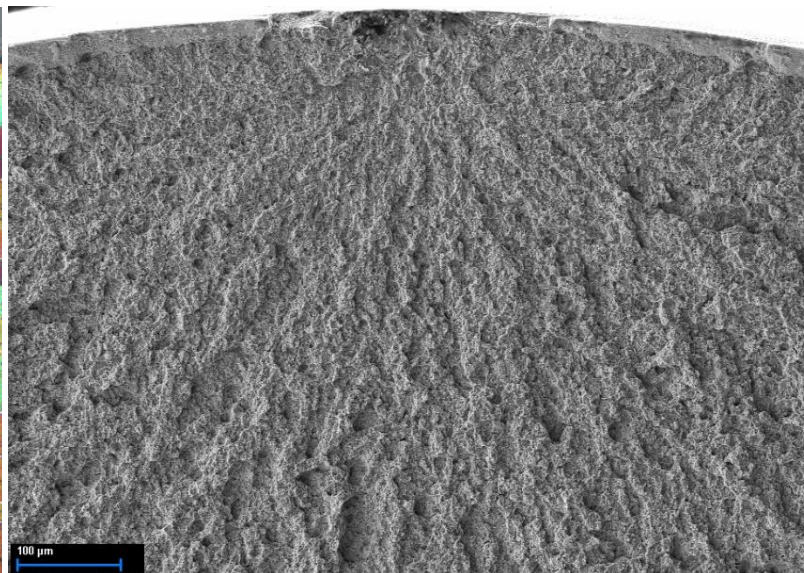
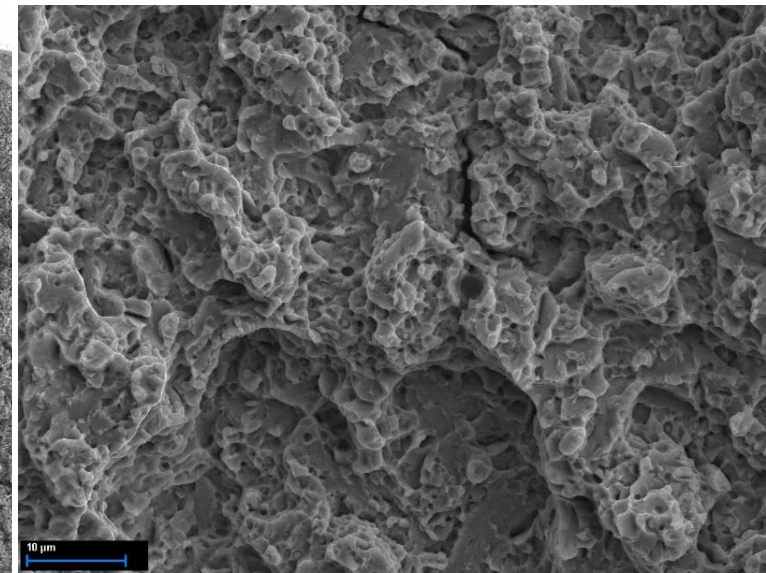
Electron-microscopic image of the cross-section (in addition to the requirements stated in the ECSS standard)

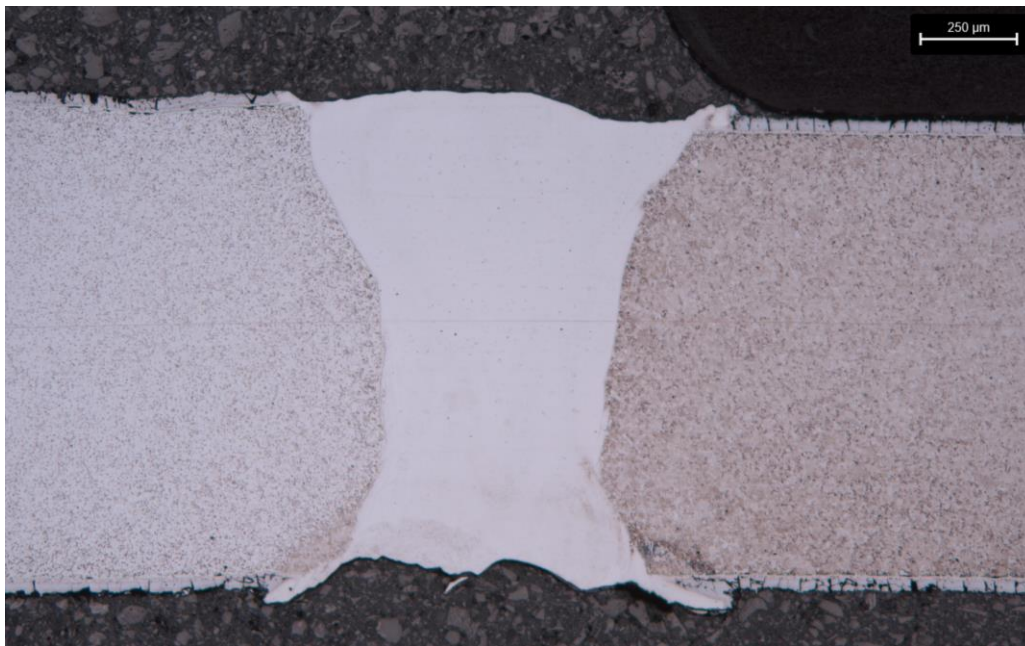
*Light-microscopic image of the cross-section
(according to DIN-EN-10359)*

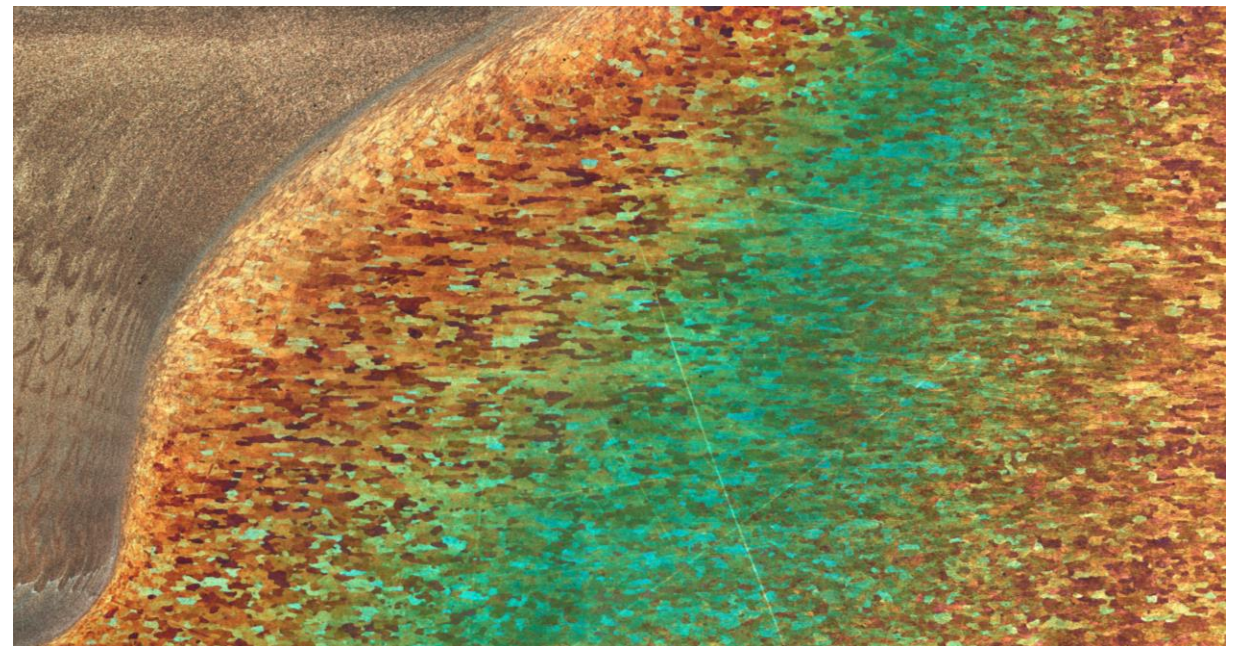
*Light-microscopic image of the chemically etched cross-section
to identify the grain structure*
