AAC – Your advanced solution for Space and Beyond

Examples of Failure Analysis Images

Christian Jogl (AAC)

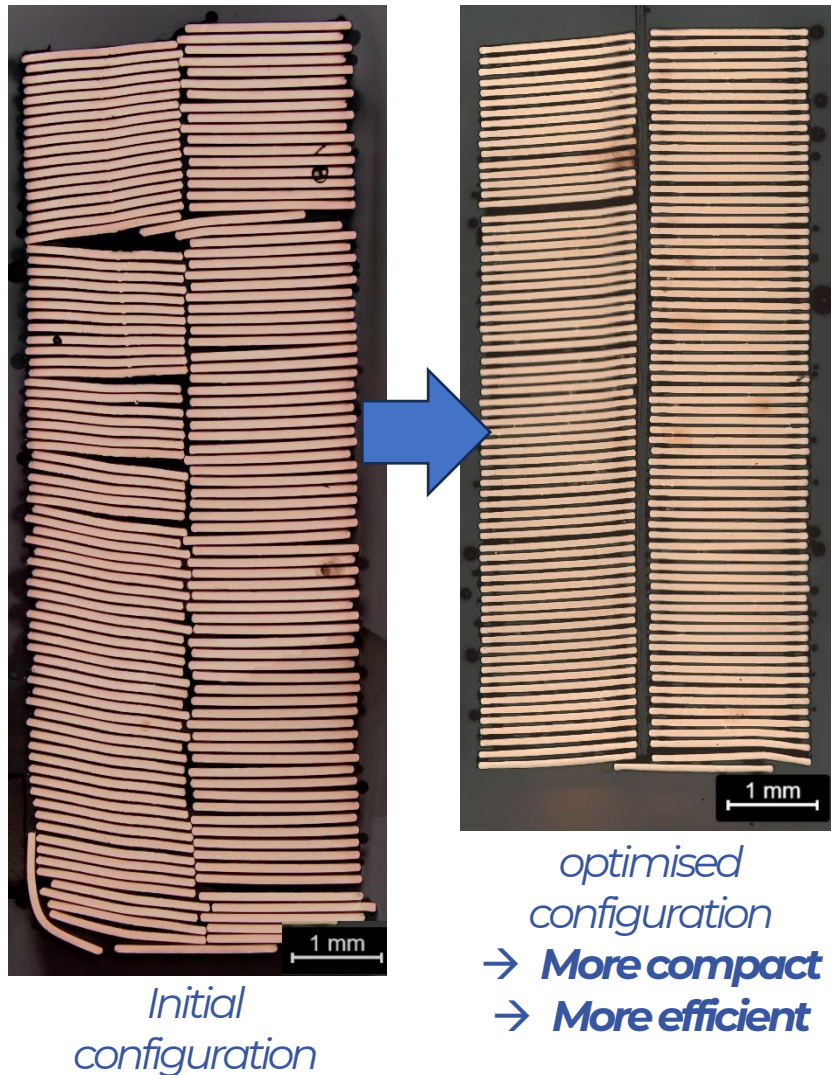
A customer developed a new type of coil with a rectangular wire cross section.

The winding machine used had to be adapted in order to obtain optimal wire layering.

After each adaptation step, a cross section was examined to assess the alignment of the wires.

This enables optimization of the manufacturing process, which leads to a reduction in component size on the one hand and an increase in efficiency on the other.
